Subject: PG&E Safety Flash- Swivel Hook

Safety Flash – Crosby Swivel Hook Failure

SAFETY ALERT: Crosby Swivel Hook Failure

Crosby Swivel Hook Failure

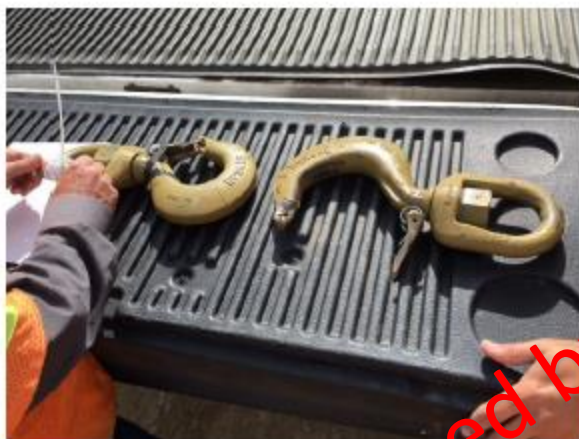
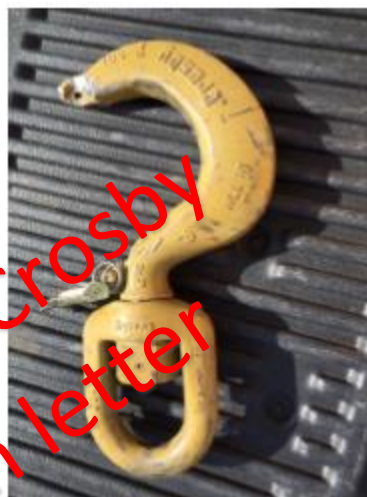
The safety flash shown on the following page was prepared by Pacific Gas and Electric (PG&E) after an incident in July 2016, that resulted in the swivel hook body being bent. Crosby was made aware of the incident through the safety flash, and contacted PG&E to assist with the evaluation. Crosby suggested that the deformation evidenced in the photograph was consistent with an overload condition and/or improper tip loading of the hook.

The hook was sent by PG&E to an independent laboratory for a detailed metallurgical analysis, and the laboratory has determined **there were no manufacturing deficiencies of the hook**. In September 2016, the laboratory concluded that **tip loading of the hook is most likely responsible** for the excessive deformation. PG&E has shared the laboratory report with Crosby, and acknowledges the tip loading condition, even though they were unable to confirm how potential misuse had occurred. Their conclusion satisfactorily removes any implied blame for the incident from the Crosby swivel hook.

CAUTION: A new S-322A Crosby swivel hook purchased from Carpenters Rigging has failed on June 7, 2016.

A trench shield was in the process of being lowered into the trench with an excavator when the new swivel hook elongated causing uncontrolled descent of the trench shield and 4-way sling onto a 12" depressurized gas transmission facility. The trench shield with spreader bars weighed 10,700 lbs. The maximum lifting capacity of the Crosby S-322A swivel hook is listed at 22,000 lbs.

Remove all 11 ton Crosby hooks from service in the field.

Inspect all rigging equipment prior to using

In the interim, ensure that crews substitute alternative approved rigging methods such as shackles until completion of the investigation.

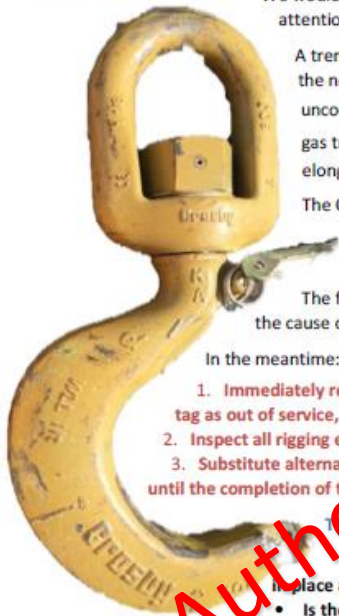
A trench shield was in the process of being lowered into a trench with an excavator when the newly purchased swivel hook unexpectedly elongated. This resulted in an uncontrolled descent of the trench shield and four-way sling down onto a depressurized 12" gas transmission pipeline. The cause of the elongation is presently unknown.

The Crosby S-322A swivel hook had a capacity of 22,000 lbs. (11 tons), while the trench shield with spreader bars weighed only 10,700 lbs.

1. Immediately remove all 11 ton Crosby hooks from service and tag as out of service,
2. Inspect all rigging equipment prior to use, and
3. Substitute alternative approved rigging methods such as shackles until the completion of the investigation.

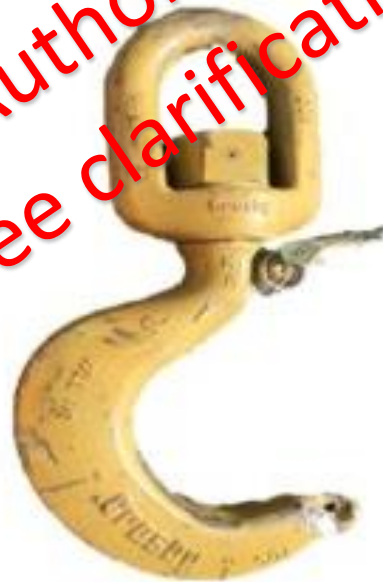
The crew was in the process of lowering a trench shield into a trench with an excavator when the (new) swivel hook unexpectedly elongated, causing the trench shield and 4-way sling to descend uncontrolled into the excavation, eventually landing on top of a gas pressurized 12" gas transmission pipeline. This particular model, Crosby 5-3224 (See Fig. 7 Below), was rated for 22,000 lbs., but failed with only the trench shield and spreader bars attached (only 9,700 lbs.). This hook was sent off to a testing lab to determine why the failure occurred.

ELONGATED HOOK

As a result of this, we are requiring any Miller Pipeline crews that may be using this model to immediately remove all applicable hooks from service, and re-tag them "Out of Service".
